**Alaska Department of Transportation & Public Facilities
Seward Highway MP 75-90**

2007 Aquatic Habitat Analysis

**HDR Alaska
2525 C Street, Ste. 305
Anchorage, Alaska 99503**

Project Number: BR-BH-NH-OA3 (35)/58105

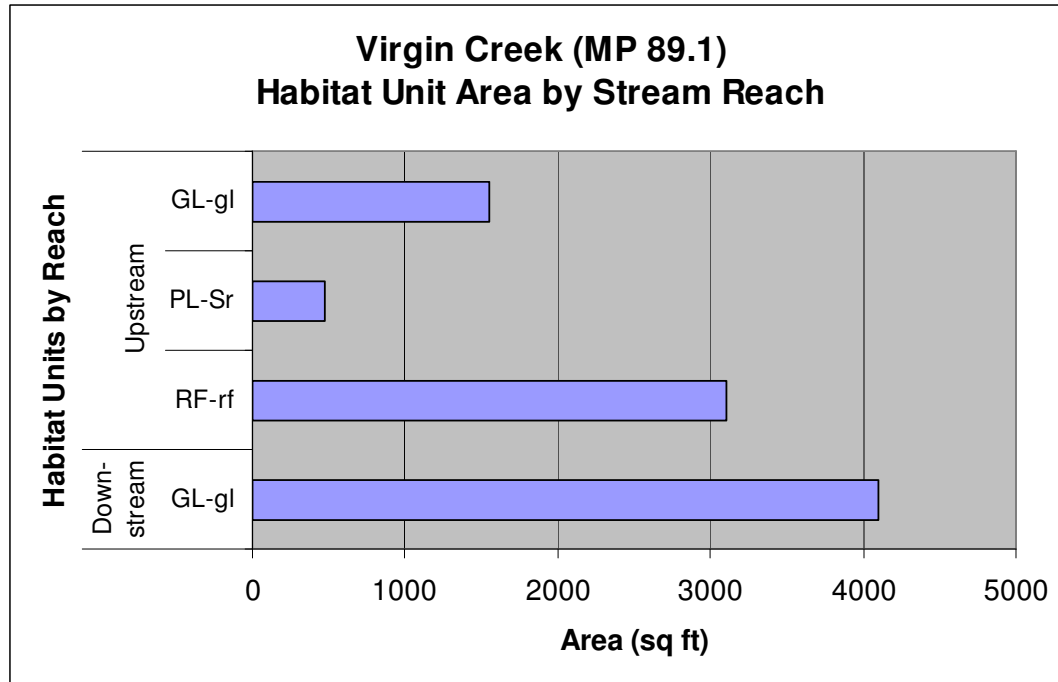
Figure 10. Virgin Creek Habitat by Stream Reach

The Virgin Creek reaches are characterized primarily by fastwater habitats including Riffle-riffle and Glide-glide habitats with a small Pool-scour habitat unit (471 ft²) occurring in the upstream reach immediately below the above-mentioned rip-rap dam (Figure 10; Appendix A-Map 3). Neither reach contained large wood and no undercut banks were observed during the 2007 survey. Wooden posts in the rip rap structure located in the upstream reach were not counted as large wood.
